SKAGIT RIVER CED RETROFIT

APRIL 4, 2005

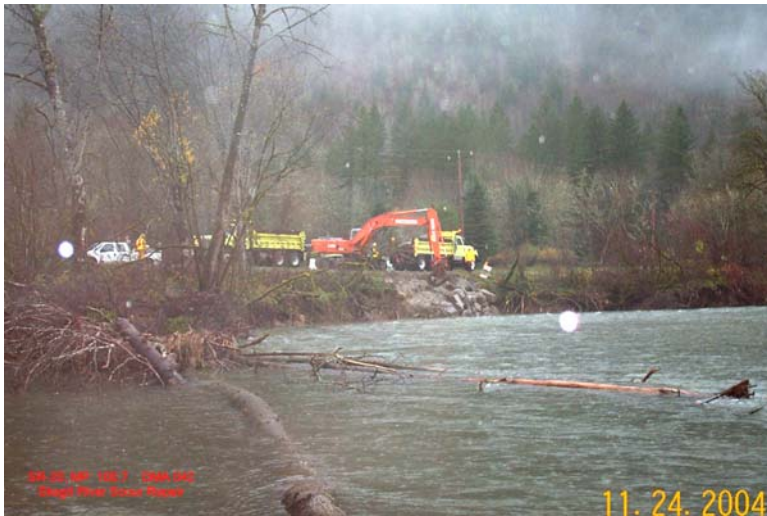
Figure 1. Placing rip-rap along SR 20.

An emergency project shored up a failing section of bank in November 2004, just in time to ward off rising flood waters, which would have washed out the road. The repair consisted of a roughened rock toe, designed in accordance with the Integrated Streambank Protection Guidelines (ISPG). It is recognized however that the repair was not adequate to serve as the long term solution to what is actually a reach based problem.

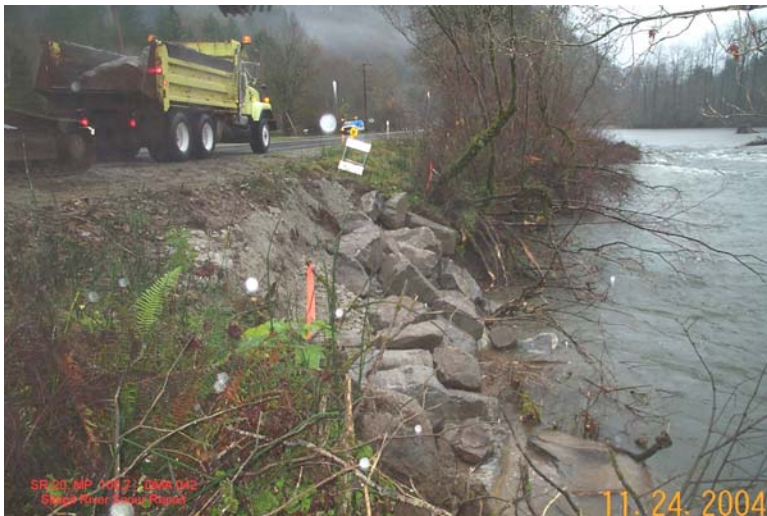
Figure 2. Placing rip-rap along SR 20.

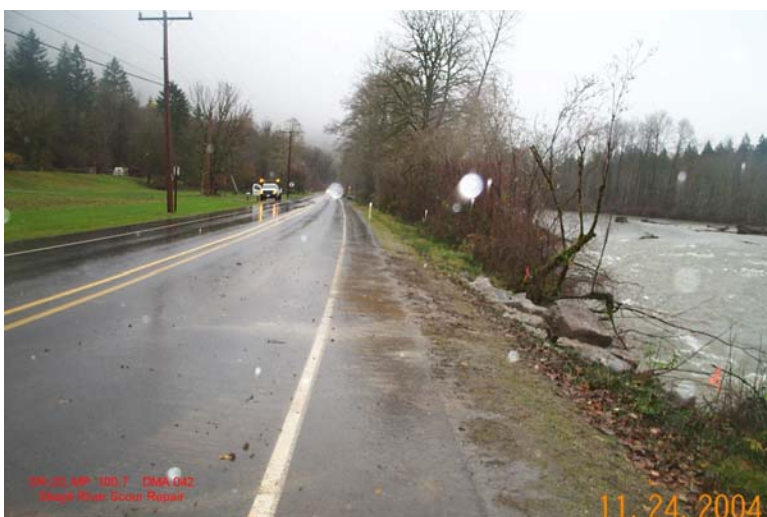
Figure 3. Rip-rap along SR 20.
